# CLEAR

## Christiana Land, Ecosystem, and Aquatic Restoration<sup>1</sup>

By Team 1:  
**Brenda Allen**  
**Maddie Hawley**  
**Emily Rodden**  
**Lori Spagnolo**

Joseph R. Biden School of Public Administration and Policy  
University of Delaware  
May 4, 2026

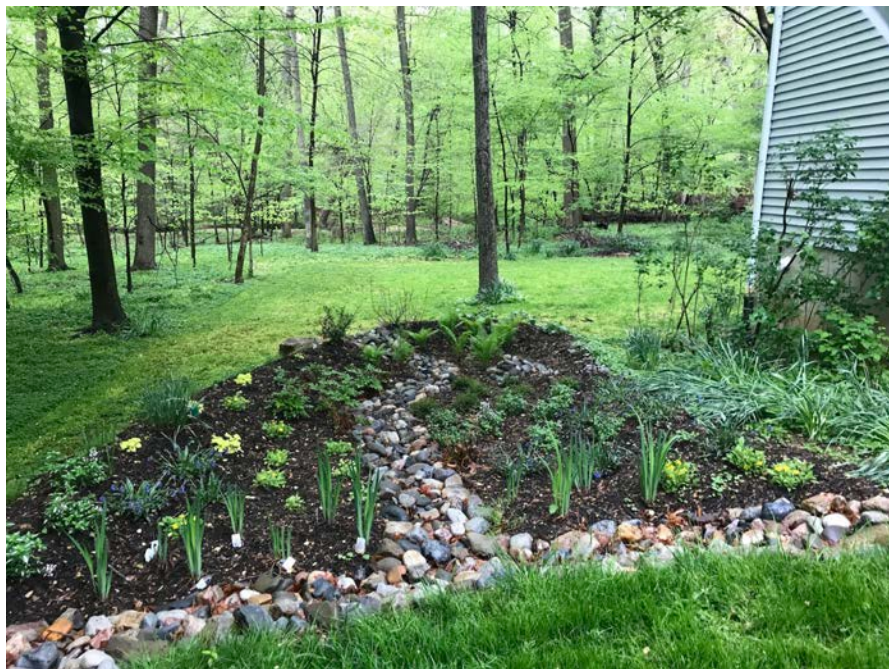
Photo #3: Example Rain Garden with Native Plants and Soil Media ([UM, 2023](#))

Rain gardens play an important role in reducing stormwater runoff and supporting local wildlife ([V'Combe, 2008](#)). They work by capturing precipitation and allowing it to slowly infiltrate the ground, which helps recharge unconfined aquifers. Recommended plant species for rain gardens in Delaware include Virginia sweetspire, buttonbush, marsh marigold, blackhaw, and many others (Jenkins and Barton, 2020).
