## BRANDYWINE SHAD 2020 WILMINGTON, DE.

## DAMS 3, 4, AND 6 REMOVAL

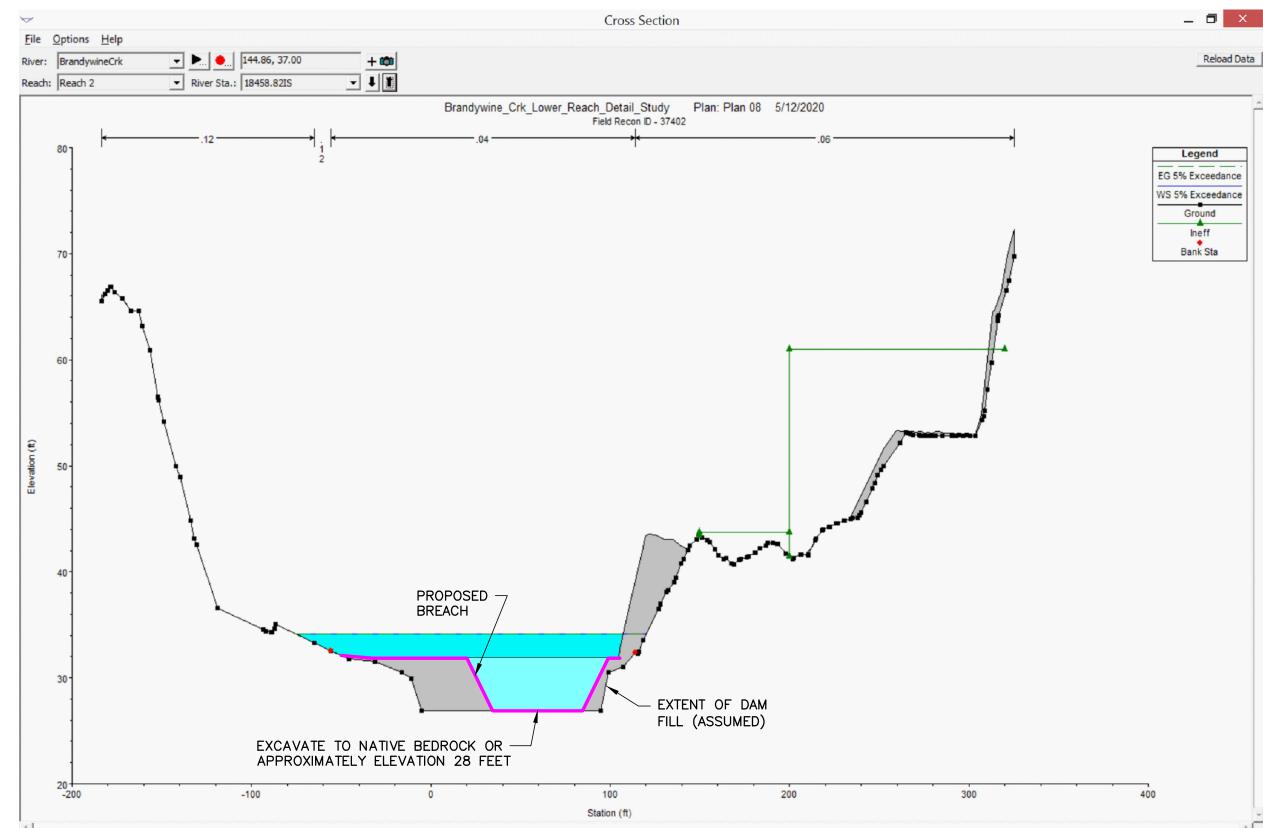
PROPOSED DAM 3 CROSS SECTION

1. BREACH SIDE SLOPES TO BE 3:1 OR PER ENGINEER FIELD DIRECTION.

2. ESTIMATED MINIMUM BREACH WIDTH AT BREACH INVERT: 51 FEET

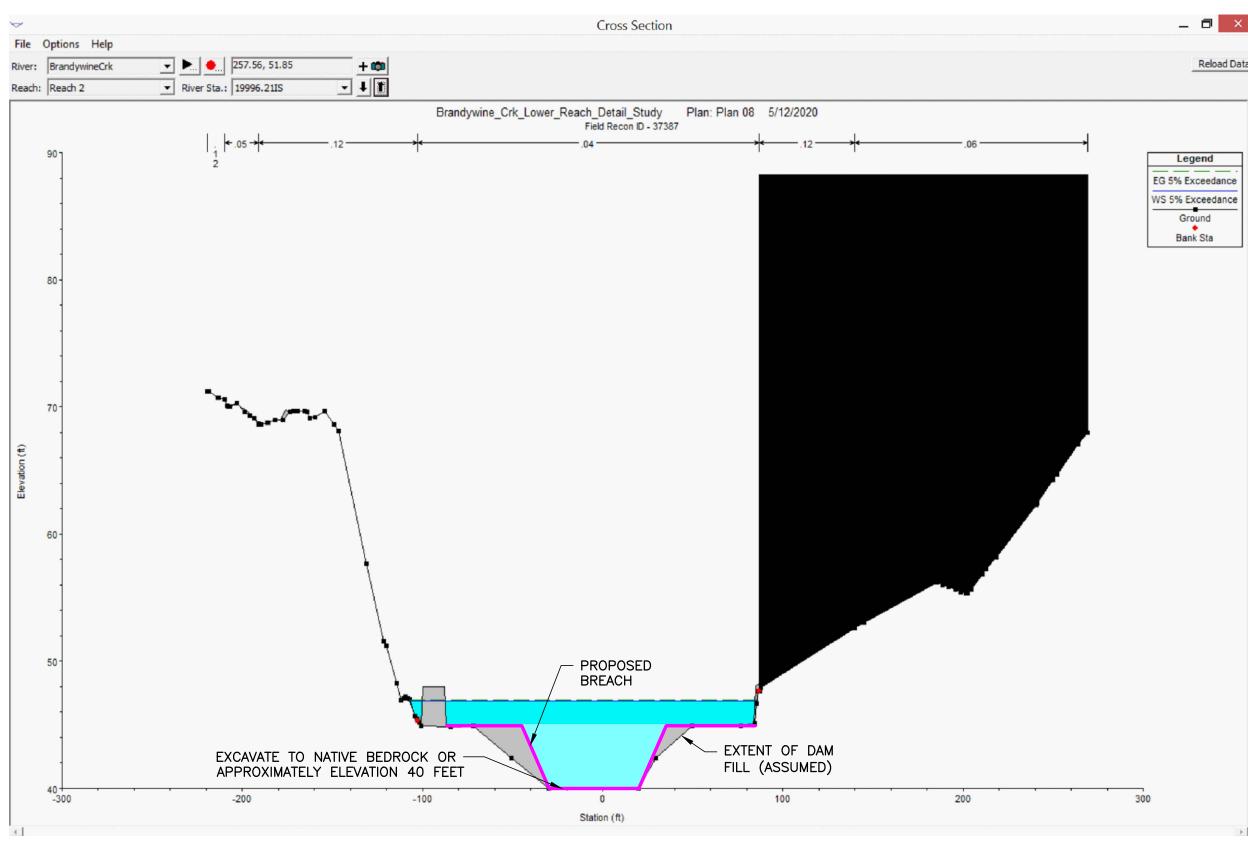
PROPOSED DAM 4 CROSS SECTION

NOTES:
1. BREACH SIDE SLOPES TO BE 3:1 OR PER ENGINEER FIELD DIRECTION.
2. ESTIMATED MINIMUM BREACH WIDTH AT BREACH INVERT: 50 FEET
